Acid attack (Acid rain, Bird droppings, Environmental contamination, Etching, Industrial fallout)

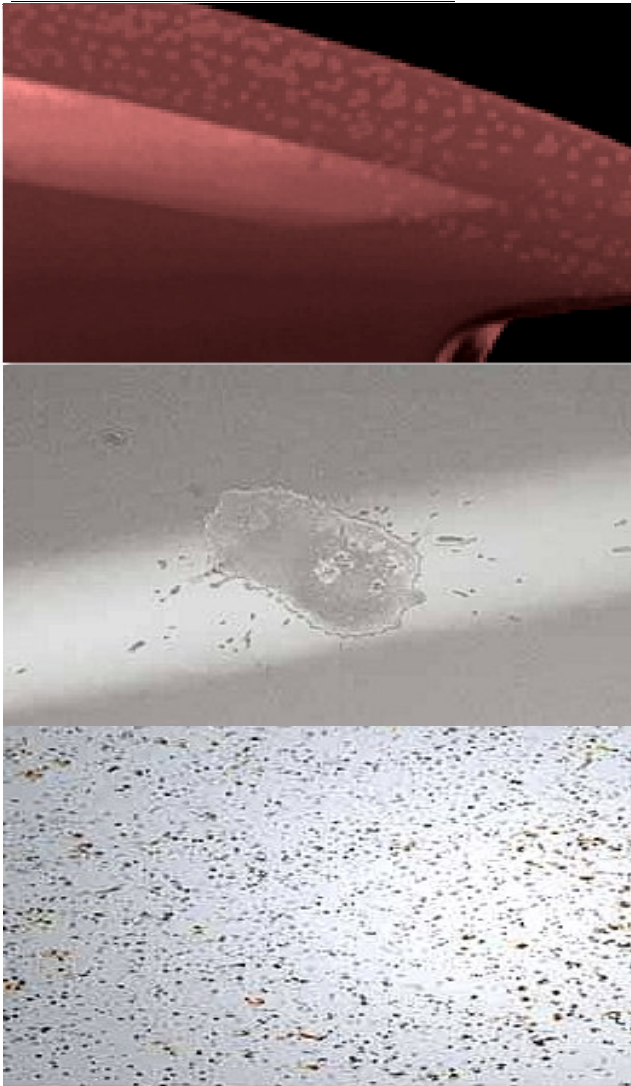
Discolored spots, irregular patches and visible etching marks in the topcoat. Disintegrating surface, loss of gloss, possible cracking or crazing in the affected area. Chemical corrosion of the paint film.

- Acid rain or industrial fallout containing effluents from chemical and agricultural industries and power stations. Industrial effluents may be acidic or alkaline, and in the presence of water they will dissolve to give acid or alkaline solutions;
- Use of detergents on new painted surfaces;

- Protect vehicle during storage;
- Immediately clean and wash with mild detergent and water;
- Frequent washing of vehicle;
- Avoid use detergent on new painted surfaces;

- Rub damaged areas with rubbing compounds and polish;
- If severe attack, remove the paint, ensure that contaminants are removed and refinish;
