### **Edge mapping** (Contouring, Featheredge splitting, Laking, Mapping, Shrinkage, Sinkage)

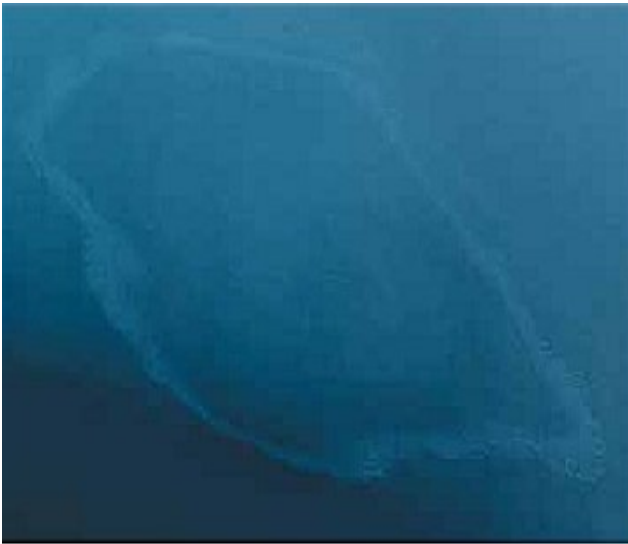
- Variation in texture and degree of gloss on areas of the painted surface. Areas are surrounded by defined contour lines.

- Polyester putty or filler incorrectly mixed;
- Excessive film thickness of undercoat layers. Solvent is trapped in undercoats that haven't had time to dry;
- Used wet on wet application over the polyester putty
- Insufficient drying;
- Improper drying, fanning with spray gun;
- Used improper or poor quality thinner;
- Too coarse finishing grit of sandpaper;

- Mix putty and filler correctly;
- Apply putty in more thin coats. If the putty is applied in too thick coats, it will shrink causing featheredge splitting;
- Do not apply wet on wet products over polyester putty;
- Apply filler in normal coats following recommended drying time;
- Use recommended thinners;
- Use correct grit of sandpaper;

- Remove paint from the affected area and refinish.
