Craters (Fish eyes, Silicone contamination)

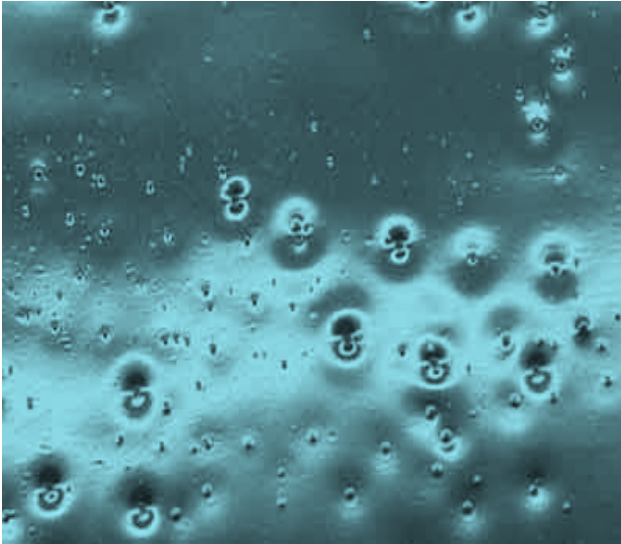
Small craters like holes. Small impurities are often visible in the centre of the crater.

- Improper surface preparation, usually involving deposits of silicones or wax on the surface of the substrate;
- Other sources of contamination, such as grease, spray dust, dried soap, detergents or oil from the air line;

- Remove all traces of silicone or wax by thoroughly cleaning the surface with a degreaser designed for this purpose. Do not allow the degreaser to dry on the surface but remove with a clean dry cloth;
- Properly maintain compressed air equipment;

- After the affected paint has hardened, remove the paint by sanding and repaint;
- In severe cases it may be necessary to add an anti silicone additive;
