Bridging

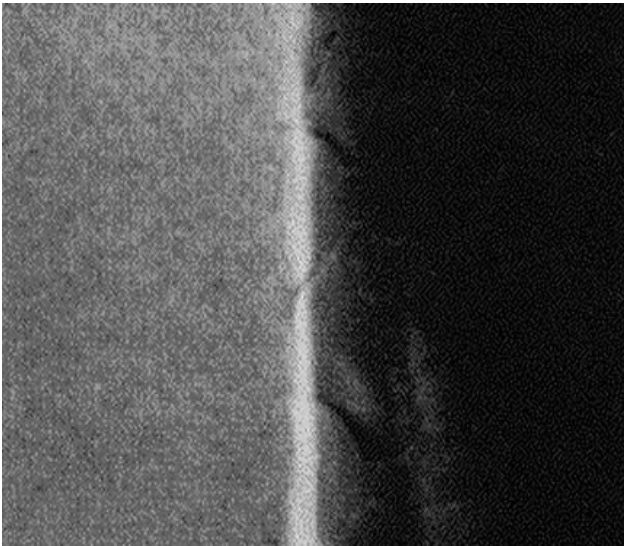
Coat cracked around sharp edges such as masking tape edges, joints, grooves, corners, etc.

- Insufficient sanding around sharp edges resulting in poor adhesion;
- Excessive paint film thickness on these areas;

- Properly prepared surface, detailed sanding around sharp edges;
- Avoid application of too heavy coats around corners and sharp edges;

- Remove paint from affected area, detail sand and refinish
- Apply lighter coats and allow prolong drying time between coats;
